HORNER AND SHIFRIN INC ST LOUIS MO
NATIONAL DAM SAFETY PROGRAM, LAKE MONTWESSE DAM (MO 30151); MIS--ETC(U)
NOV 78
DACW43-78-C-0143

SUBJECT: Lake Montowese Dam, Phase I Inspection Report

PHASE I INSPECTION REPORT
NATIONAL DAM SAFETY PROGRAM
LAKE MONTOWESE DAM - ID NO. 30151

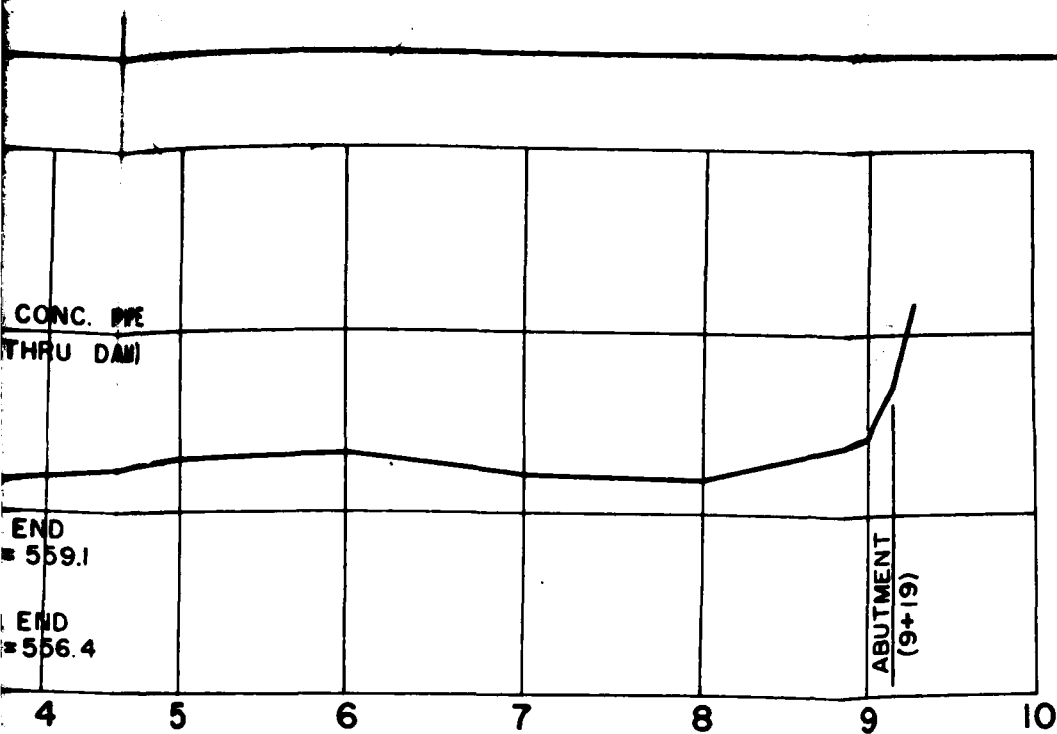
LAKE MONTOWESE
DAM & SPILLWAY PROFILES
Horner & Shifrin, Inc. August 1978

The elevation of the top of the dam, as determined by survey, was found to vary by about 1.3 feet with the lowest point located approximately 320 feet from the spillway. A profile of the dam crest extending through the spillway is shown on Plate 4.
